UTTARAKHAND ELECTRICITY REGULATORY COMMISSION

Electrocution of Sh. Bhagwant Lal S/o Shri Prem Ram residence of village- Aholi Sunar (Syali), P.O.- Syalidhar, Distt.- Almora on 13-14.08.2008 at 02:00 Hrs.

Date of Order: 22nd September 2009

ORDER

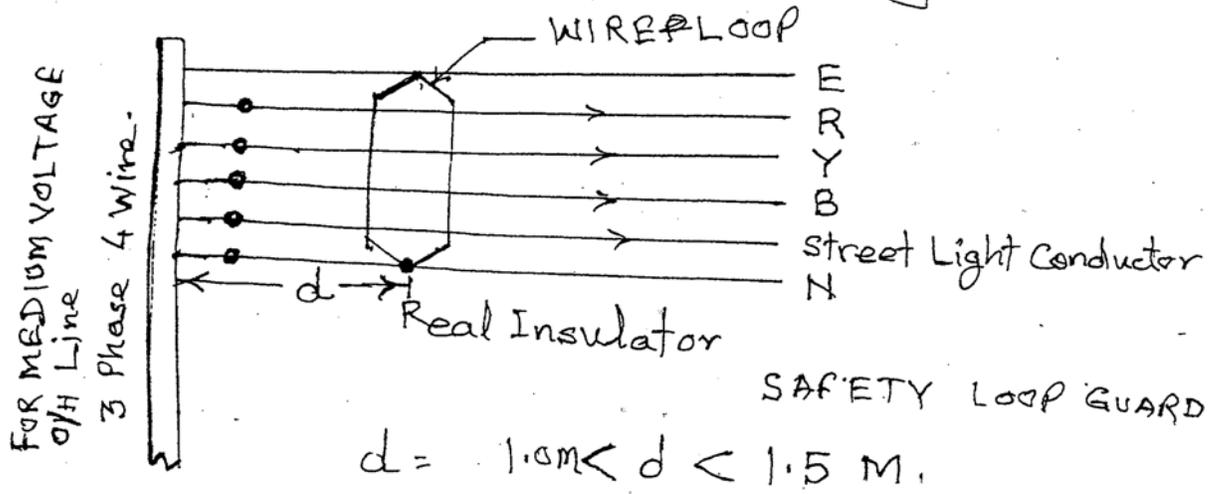
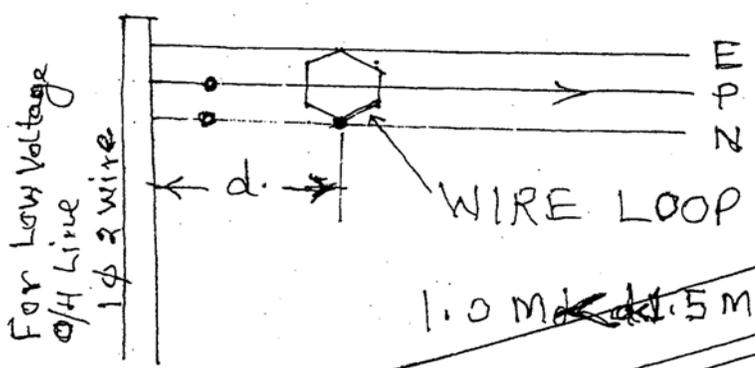
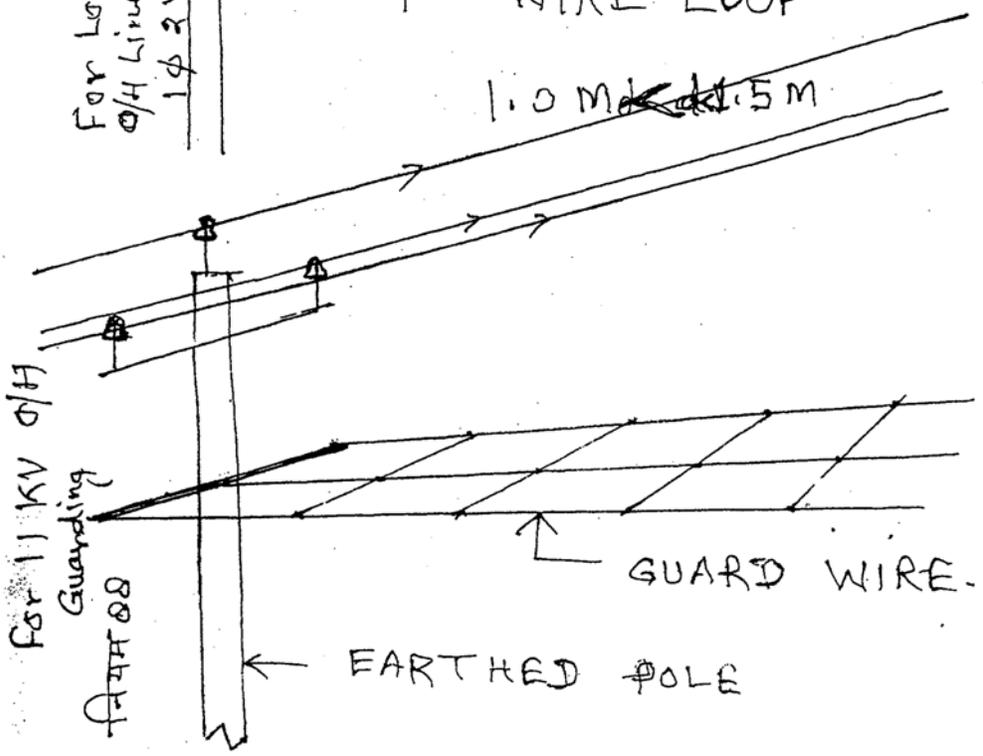
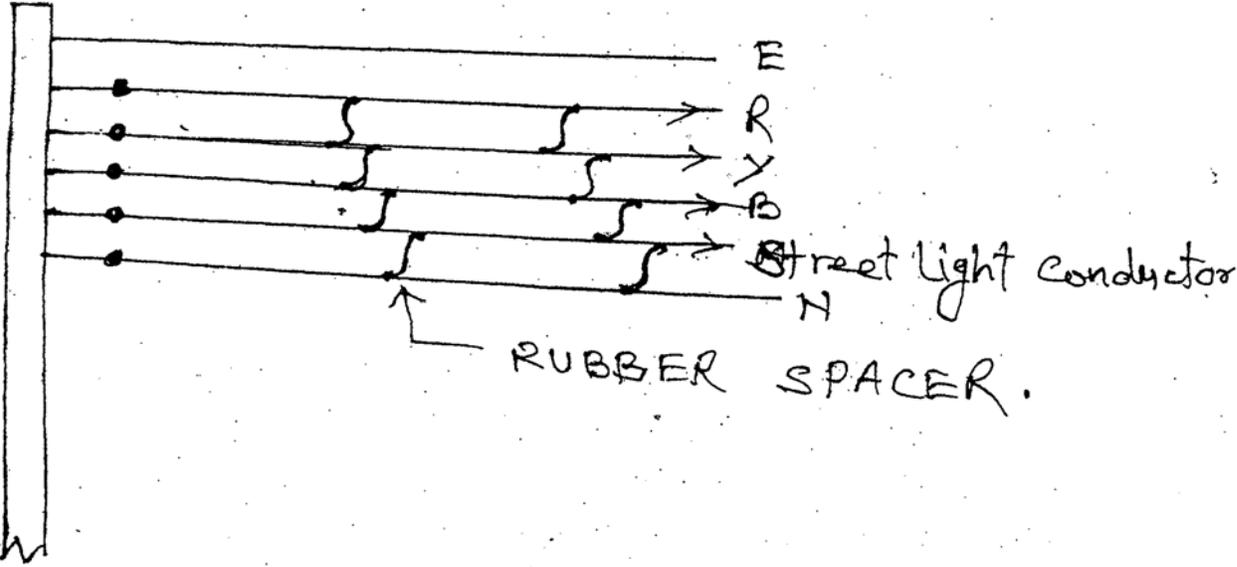
नियम 91(1) के अन्तर्गत गाड़िंग अन्वय युक्तियां

- 2- एल०टी० एवं मीडियम वोल्टेज ओवर हेड लाइन में सेप्टी लूप गार्ड की व्यवस्था पोल के दोनो ओर " 1 मीटर से 1.5 मीटर की दूरी पर इस प्रकार की जायेगी कि सजीव तार टूटने की स्थिति में जमीन पर गिरने से पूर्व निर्जीव हो जाये। ड्राईंग संलग्न है तथा एल०टी० ओवर हेड लाईनों में उक्त युक्ति हेतु स्पेशर की व्यवस्था भी कराई जा सकती है।
